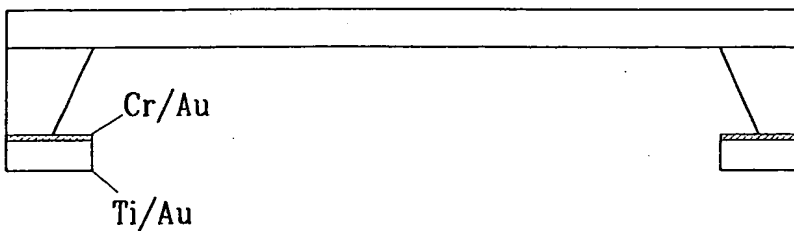
FIG. 4B

- * Cr/Au deposition
- * Photolithography #1
- * Au/Cr etch
- * Hardbake of photoresist
- * Glass etching

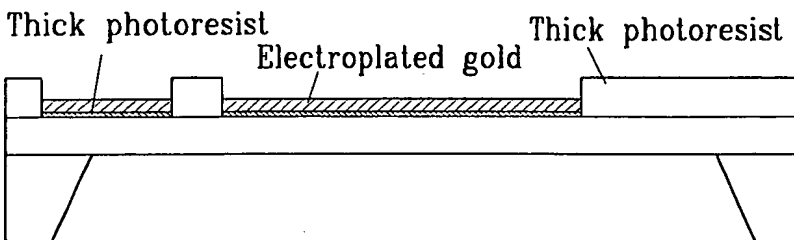
FIG. 4C

- * 1st seed layer deposition
- * Photolithography #2
- * Electroplating

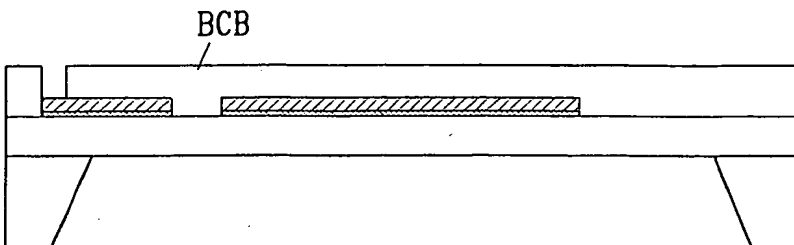
FIG. 4D

- * PR strip
- * Seed layer etching
- * BCB coating & baking
- * BCB patterning

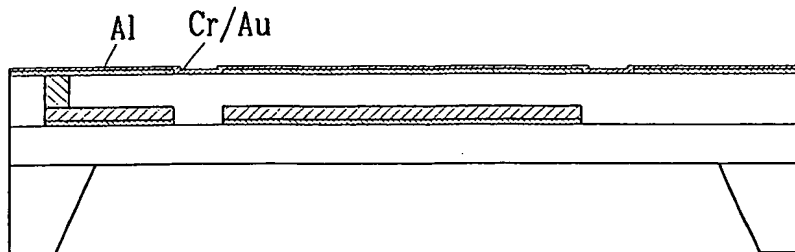
FIG. 4E

- * Au electroplating (for via)
- * Al mask deposition
- * Photolithography #3
- * Al etching
- * 2nd seed layer deposition

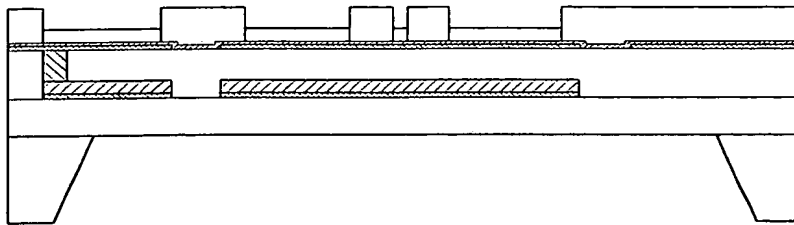
FIG. 4F

- * Photolithography #4
- * Au electroplating

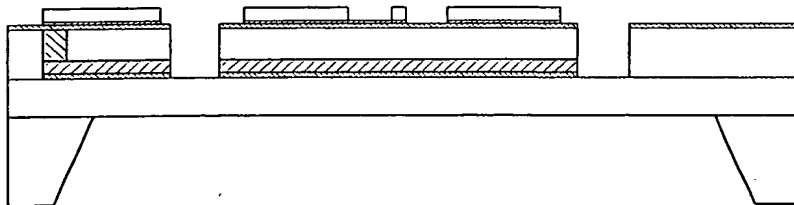
FIG. 4G

- * PR strip
- * Seed layer etching
- * RIE of BCB

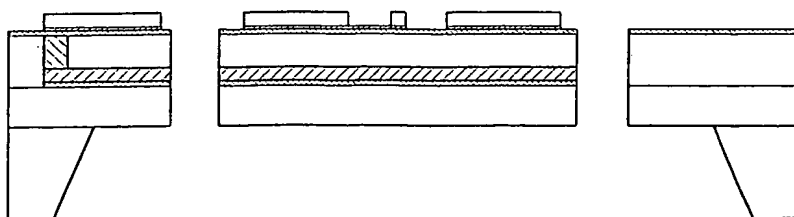
FIG. 4H

- * Silicon deep RIE
